NATIONAL TRANSPORTATION SAFETY BOARD

Group Chairman's Factual Report

AIR TRAFFIC CONTROL

DCA13MA120

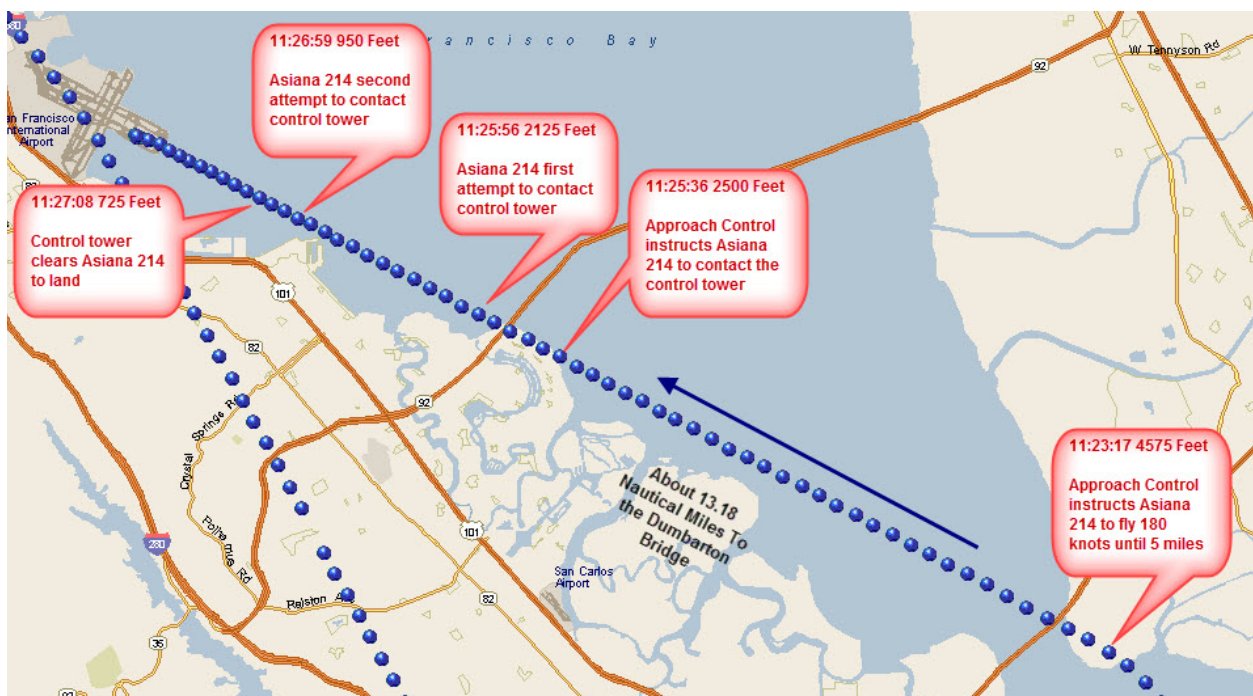
Figure 3 - ADS-B plots showing the full final approach segment.

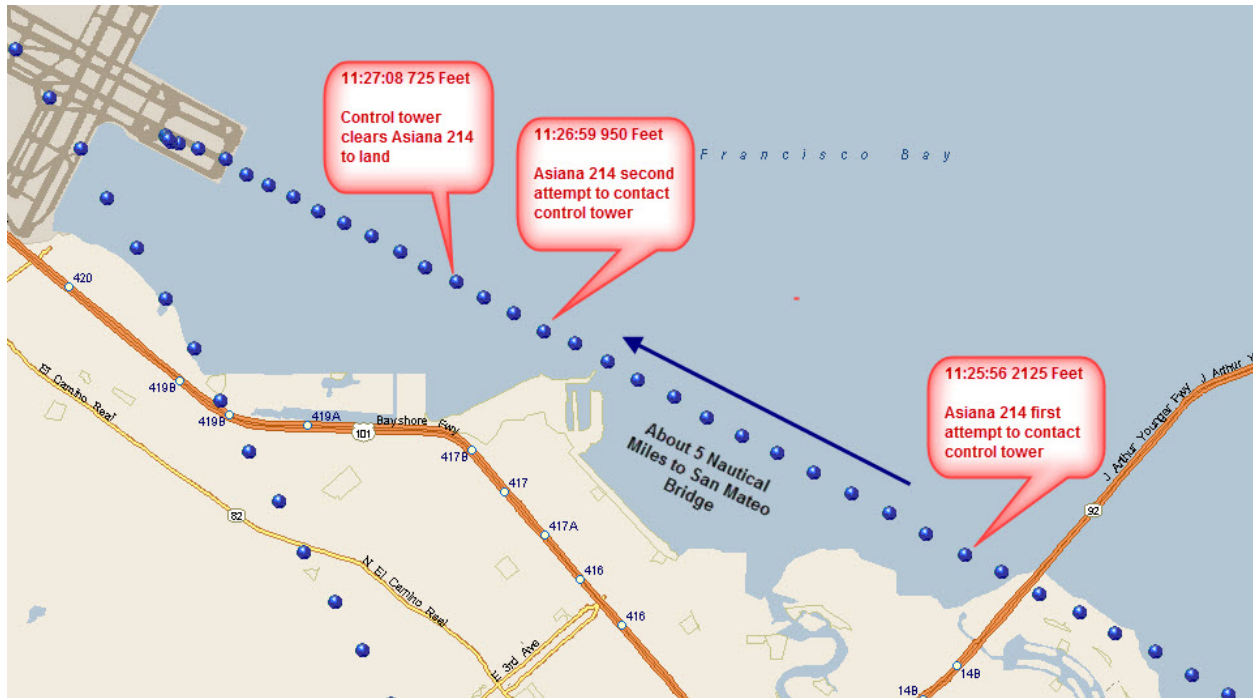
Figure 4 - ADS-B plots of the final approach segment.

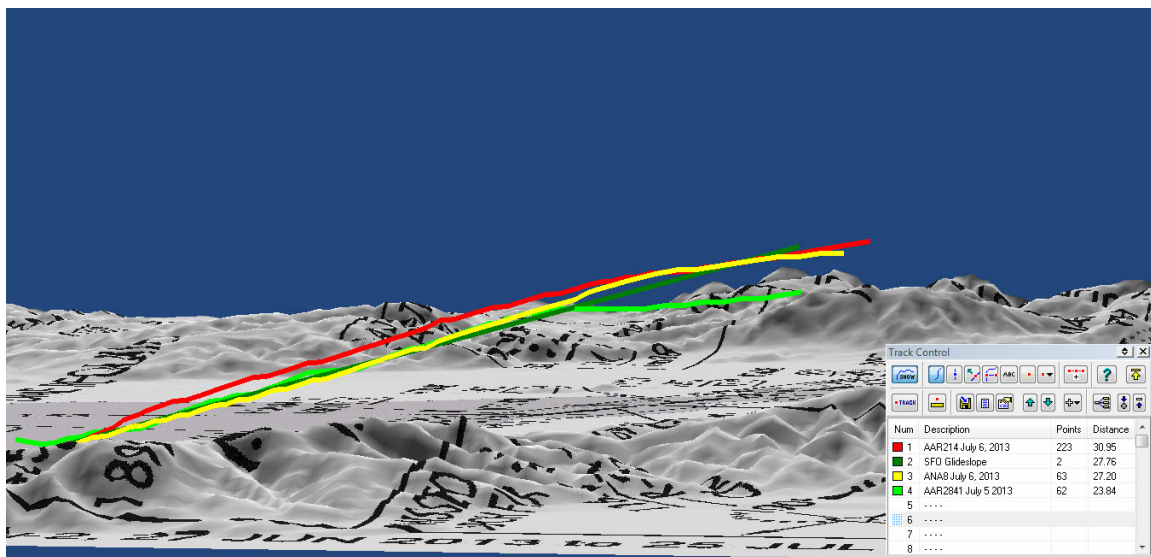
Figure 8 – A profile view of the plotted radar tracks of the accident airplane, ANA8, and AAR2841.

All Nippon Airways flight 8 (ANA 8), a B777, was immediately preceding AAR214 on the visual approach, and intercepted the final approach course about 11 miles from the end of runway 28L. At that point, ANA8 was descending through 4,100 feet. When AAR214 passed the same point on final approach, it was also descending through 4,100 feet.
